Safety Inchibit Safety Magazine

The Airbus Safety Magazine For the enhancement of safe flight through increased knowledge and communications

Safety First, #13 January 2012. Safety First is published by Airbus S.A.S. - 1, rond point Maurice Bellonte - 31707 Blagnac Cedex/France. Editor: Yannick Malinge, Chief Product Safety Officer, Nils Fayaud, Director Product Safety Information. Concept Design by Airbus Multi Media Support Ref. 20111714. Computer Graphic by Quat'coul, Fixion. Copyright: GS 420.0043/11. Photos copyright Airbus. Photos by ExM Company: P. Masclet. Printed in France by Airbus Print Centre. © Airbus S.A.S. 2012 – All rights reserved. Proprietary documents.

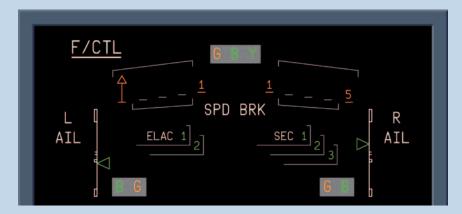
Figure 1B A320 ECAM <u>F/CTL</u> page: spoiler n°5 indicated fault deflected

► Once it crosses that threshold, a <u>F/CTL</u> SPLR FAULT amber caution is triggered and the affected spoiler is indicated fault deflected in amber on the ECAM <u>F/CTL</u> page (fig. 1B).

► From then on, it is considered that the affected spoiler generates a non negligible increase of the fuel consumption, which will evolve over time, as the spoiler extends further.

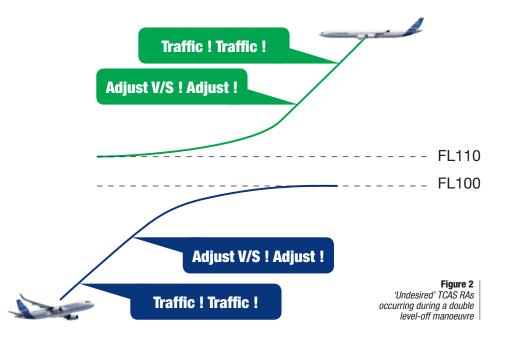
Figure 3 Example of nuisance TCAS alerts occurring during a double level-off manoeuvre

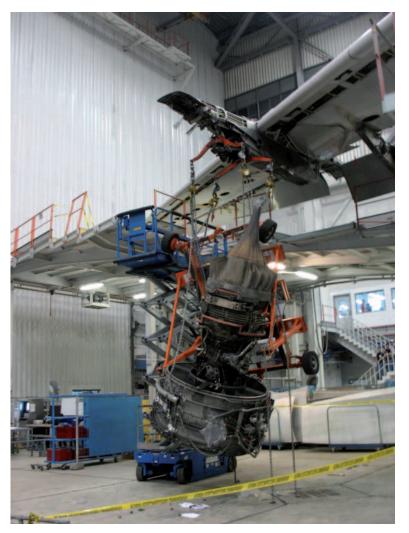
Figure 1 Consequence of failed bootstrap

Investigations of several cases of engine drops have determined that the hoist maintenance had never been done, and that the braking system was either damaged or showed presence of oil.
