Safety Inchibit Safety Magazine

The Airbus Safety Magazine For the enhancement of safe flight through increased knowledge and communications

Safety First, #13 January 2012. Safety First is published by Airbus S.A.S. - 1, rond point Maurice Bellonte - 31707 Blagnac Cedex/France. Editor: Yannick Malinge, Chief Product Safety Officer, Nils Fayaud, Director Product Safety Information. Concept Design by Airbus Multi Media Support Ref. 20111714. Computer Graphic by Quat'coul, Fixion. Copyright: GS 420.0043/11. Photos copyright Airbus. Photos by ExM Company: P. Masclet. Printed in France by Airbus Print Centre. © Airbus S.A.S. 2012 – All rights reserved. Proprietary documents.

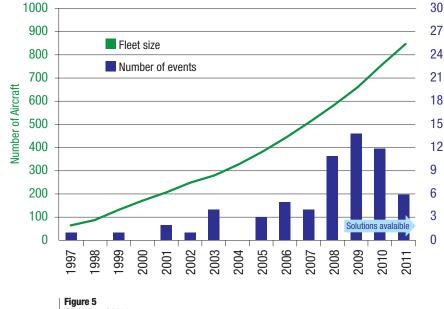
Evolution of A.3.30 Dual Bleed Loss events

The following technical solutions (ref. E) have significantly reduced the number of bleed losses due to overtemperature (fig. 5):

New functional test procedures have been developed to allow an earlier detection of the drift as well as an easier detection of faulty components. Specific health monitoring of the FAV is also recommended at the same interval as the ThC filters cleaning.

A key parameter to maintain an optimum serviceability of the component is to adjust the interval for ThC filters cleaning or replacement, depending on the severity of the operating environment. Implementation of this preventive maintenance procedure and customization of the interval are available from MPD and via specific SIL (ref. B).

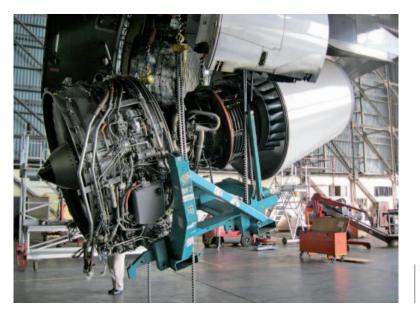
Figure 2 consequence of disengaged chain pulley

► On the second event, an engine fell to the ground during its removal. The forward left chain pulley disengaged while the maintenance team was performing Aircraft Maintenance Manual (AMM) subtask 71-00-00-020-053-A(fig. 2).

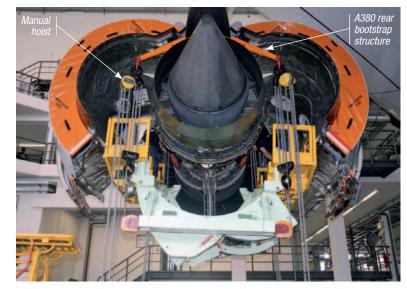
Figure 3 A380 bootstrap structure

As an example, let us consider the bootstrap (fig. 3). It consists of two main parts:

► The lifting device (chain hoist), which is the interface between the structure and the assembly to lift (the engine cradle). The lifting device is a device available on the market. The suppliers of the lifting device specify the maintenance recommendations to be applied. Typically, a visual inspection should be done every time the tool is used, and the friction brakes should be inspected at specified intervals.

Investigations of several cases of engine drops have determined that the hoist maintenance had never been done, and that the braking system was either damaged or showed presence of oil.

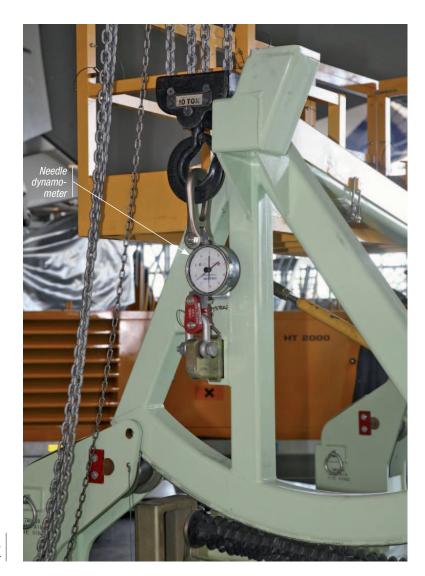
Figure 4 Needle dynamometer

The bootstrap system is equipped with needle dynamometers (fig. 4) indicating the applied loads. The approaching phase is sensitive because the technicians have to continuously monitor the loads applied on the bootstrap system. Several mechanics, working as a unit, are required to perform this operation. They have to ensure proper communication amongst the team in

order to ensure a balanced bootstrap movement and an adequate load monitoring at all times. An overload may cause a life threatening structural failure of the bootstrap. The AMM provides the references for the standard tool, which in combination with the described procedures ensures a safe operation during engine removal and installation.

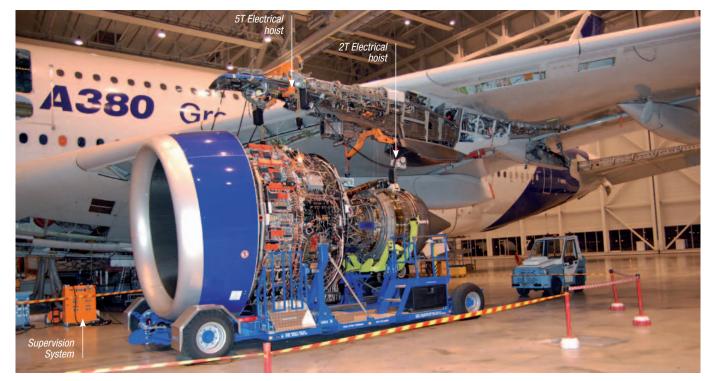
Figure 5 Electric bootstrap tool

In addition to the standard tool required by the AMM, Airbus has developed a new "electrical bootstrap" tool (fig. 5).
